# LANDMARKS LOANS

A FUNDING SOURCE FOR HISTORIC BUILDINGS

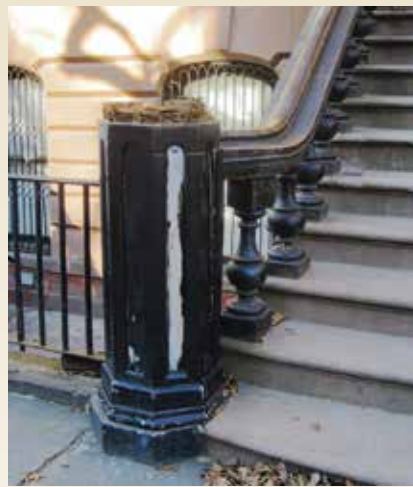
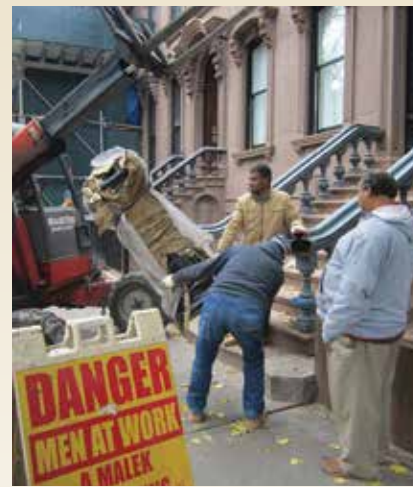
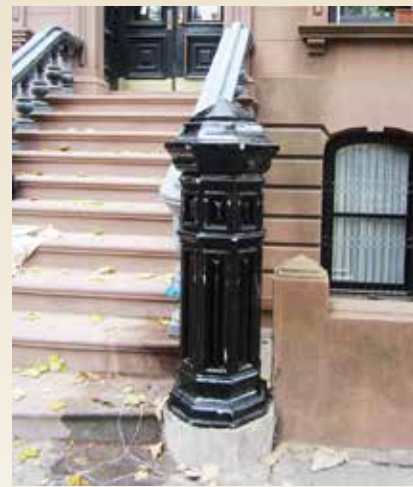
The brownstone at 6 South Portland Avenue in Fort Greene Historic District in Brooklyn was coming apart. The front steps were crumbling, the facade was cracking, and the original cast-iron newel posts at the base of the front steps had been replaced with wooden facsimiles covered with black paint. “I removed one with my hands one day,” says Andrew Parker, president of the self-managed six-unit co-op. “It was just rotted plywood.”

Before, during, and after the newel post replacement at 6 South Portland Avenue in Fort Greene, Brooklyn.

The contractors also recreated original floral details and coats of arms that had once been carved into the brownstone around the tall front door and windows but had chipped away over the years. Someone had added a carved face over the front door. "It is a little unusual," Mahoney says. "It's not an original detail, though it was there when the Fort Greene Historic District was created in 1978." In a crowning touch, the project architect arranged with a company in India to create historically accurate, cast-iron newel posts for just \$8,000, including shipping. These newel posts will never turn into sawdust.

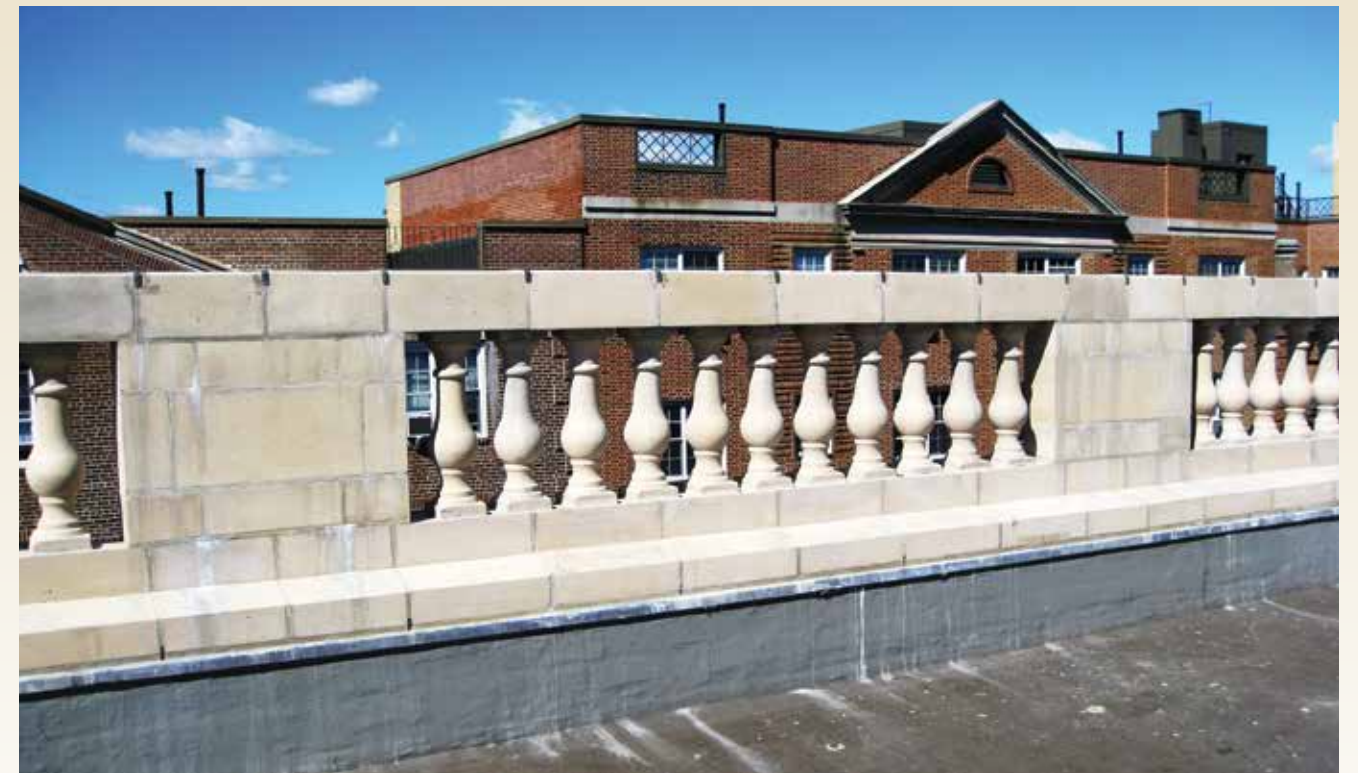
needed a new roof and extensive brick repointing, and the terra-cotta cornice was crumbling. But like its Brooklyn counterpart, the co-op didn’t have the cash or the expertise to repair a century-old building. “We’re self-managed,” says Mark Kempson, a board member. “We don’t have a lot of knowledge about historic rehabilitation.”

Cornice repair work in the Jackson Heights Historic District.

With technical assistance from the conservancy, the co-op repointed bricks and replaced the roof but then ran into a snag when it tackled the cornice. The original was made of terra cotta, and though the conservancy favors using original materials when replacing building components,

the cost was more than the co-op could bear. So the new cornice was made of cheaper composite stone.
